Another Express Polymers SOLID SOLUTION!

Express Polymers has a simple solution.

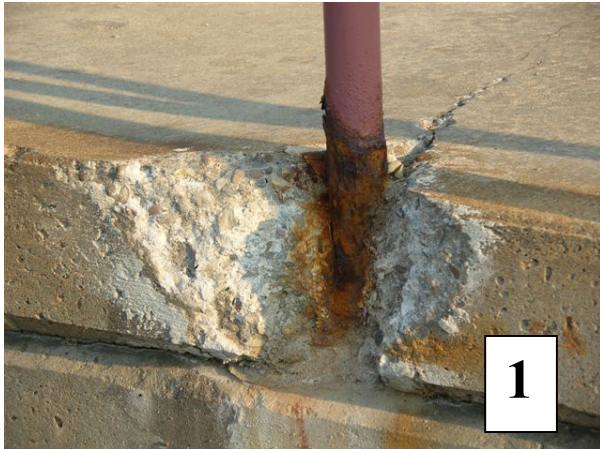
1

Anchoring hand rails in concrete causes an inherent problem. The failure below occurs because the concrete consistently cracks at the point where the railings are anchored. This is simply due to the summer heat and winter cold causing the metal railing to expand and contract at a different rate than the anchoring material and most anchoring materials are so hard that they can't flex enough to handle the expansion. The resulting cracks allow water to enter and this continues in winter where freezing and thawing heaves the concrete until it eventually pops off. (See photo 1)
